# Manhole Inspection Summary

Manhole # S55M\_\_018MH

Insp Date: **6/6/08 9:36 AM**

**Location** Address: **1000 baylis st**

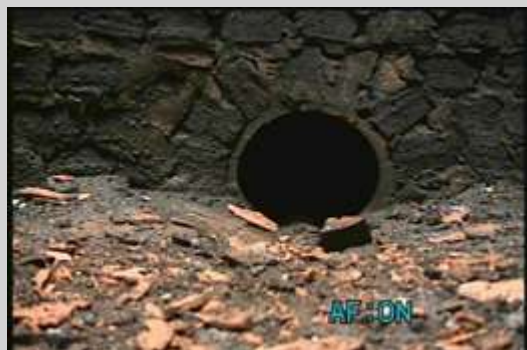
12 O'Clock Outflow

8 in. Circular Gravity Sewer  
Pipe Out @ 12 O'Clock

Pipe Material: **Clay** ☐ Pipe Lined

Infiltration: **None** Pipe Seal Cond: **Unknown**
